18SP627* – MBE4000 Oil Gallery Cup Plug Repair Kit

KIT DESCRIPTION

A new service kit (P/N: 23536000) is now available for replacement of three oil gallery cup plugs on the MBE4000 engine.

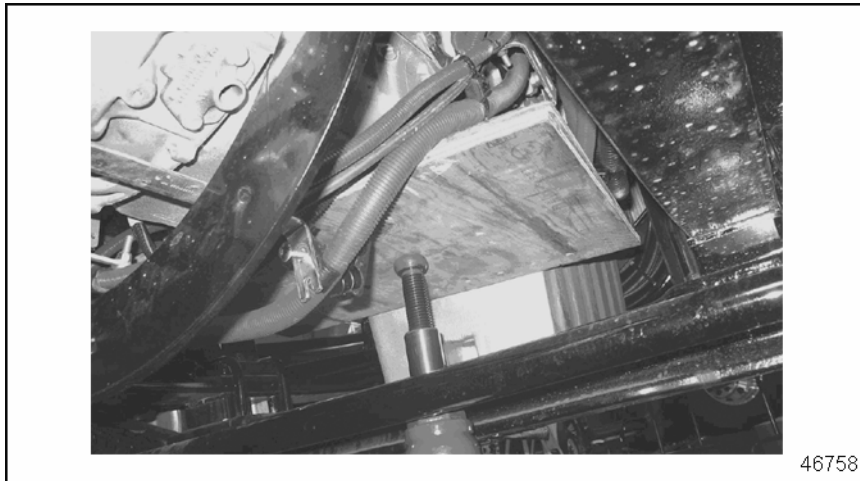
Figure 1 Floor Jack Engine Support by Shallow Portion of Oil Pan

- b. If the engine has NOT suffered a cup plug failure, DO NOT remove the oil pan and DO NOT replace the oil pan gasket. Support the engine by placing a suitable floor jack under the shallow portion of the oil pan. Place a board between the oil pan and the jack. This board needs to be at least $\frac{3}{4}$ in. thick plywood that covers most of the shallow part of the oil pan. See Figure 1. Wrap a suitable chain around the frame rails and under the engine to act as a safety sling in case the floor jack fails.

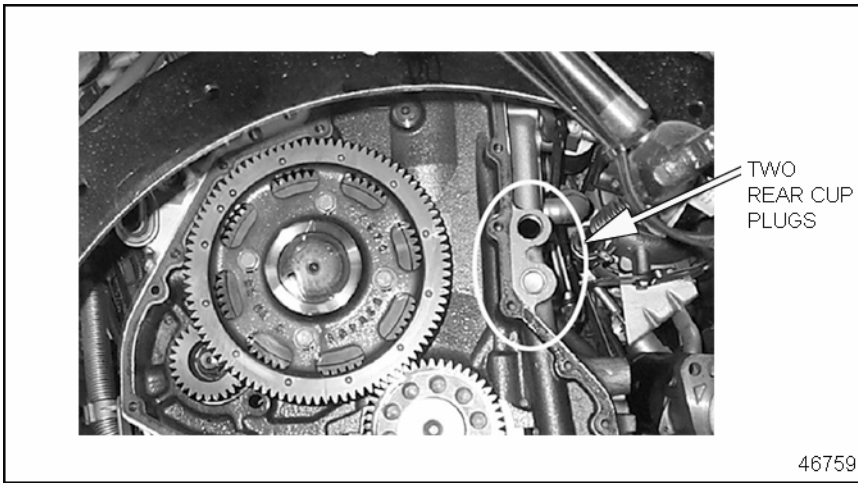
Figure 2 Removal of Two Rear Cup Plugs

8. Remove the cup plug(s) using the following procedure. Make sure not to damage the plug bores in the cylinder block. See Figures 2 - 4.
 - a. Use a punch or chisel to hit the bottom of the cup plug near one side to turn it sideways. See Figure 3.
 - b. After turning the plug sideways, use pliers to grab the cup plug as shown in Figure 4.
 - c. Carefully pull the cup plug from the engine block as shown in Figure 4.

Remove the two former rear cup plugs and install the two new rear cup plugs as follows (see Figures 1-6):

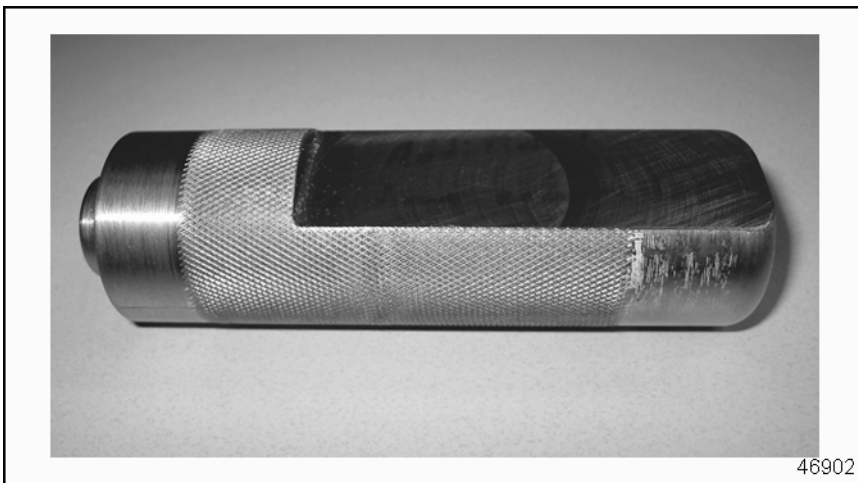
Figure 5 Kent-Moore Tool J-47394

9. Using a dry shop towel, clean both cylinder block plug bores so they are clean and dry.
10. Apply a uniform layer of Loctite 680 all around the side surface of the new cup plugs.
11. Using Kent-Moore tool J-47394, carefully drive the new plugs into the cylinder block until the tool seats against the block. When properly installed, the plugs will be 1.4-1.7mm (0.055-0.066 in.) below the block surface. See Figures 5 and 6.

1. Apply the parking brake, chock the wheels, and perform any other applicable safety steps.
2. Disconnect vehicle battery power.
3. Remove the former cup plug. Make sure to not damage the plug bore in the cylinder block. See Figures 3 and 4.
4. Using a dry shop towel, clean the cylinder block plug bore so it is clean and dry.
5. Apply a uniform layer of Loctite 680 all around the side surface of the new cup plug.
6. Using Kent-Moore tool J-47394, carefully drive the new plug into the cylinder block until the tool seats against the block. When properly installed, the plug will be 1.4-1.7mm (0.055-0.066 in.) below the block surface. See Figures 5 and 6.

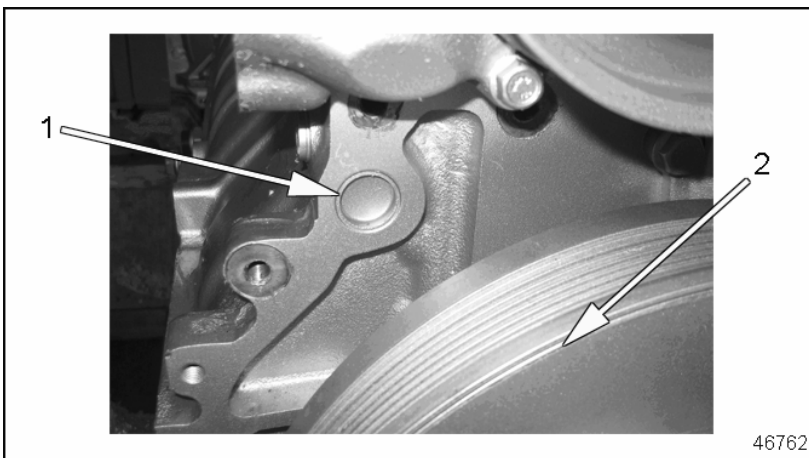
Figure 7 Front Cup Plug Location

Install the new front cup plug as follows (see Figure 7):

1. Front Plug

2. Damper
